CITY OF CORONADO

CITY COUNCIL STAFF REPORT

REQUEST COUNCIL DIRECTION FOR FINAL DESIGN AND AUTHORIZE BID ADVERTISEMENT FOR THE LAWN BOWLING GREEN TURF REPLACEMENT PROJECT

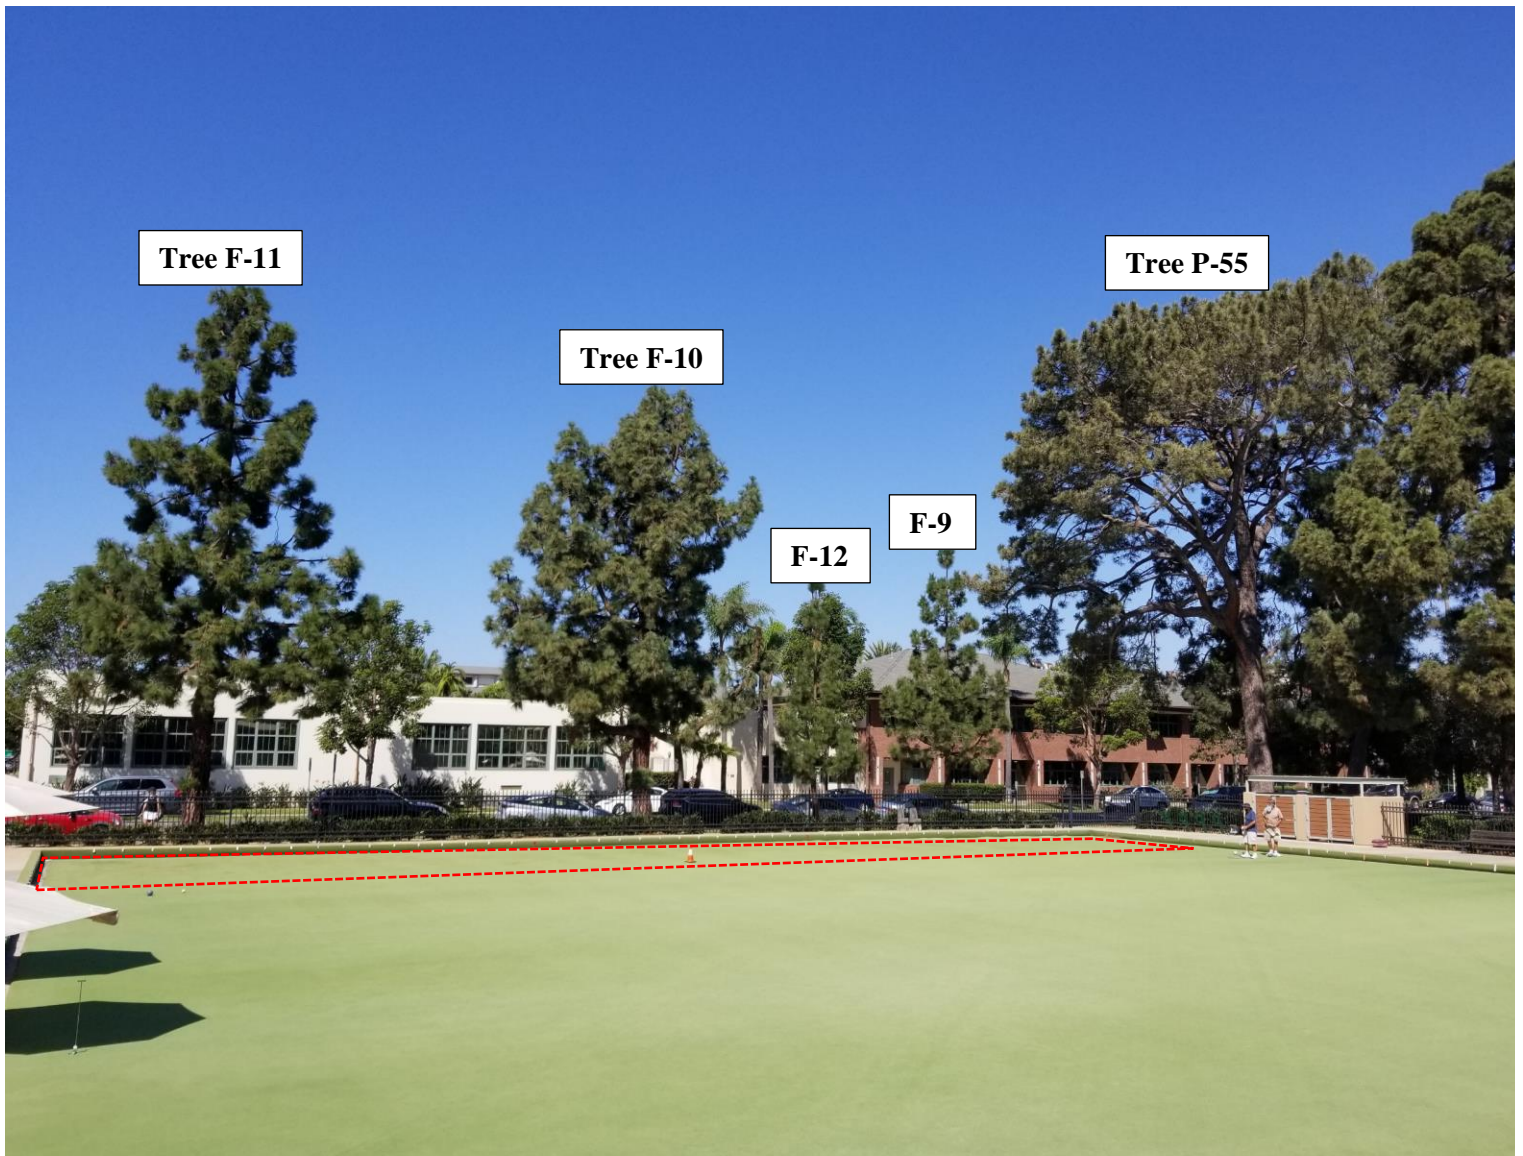
Photo #1

- The subject trees were located on the northwest side of the Coronado lawn bowling club and were surrounded by irrigated turf grass.
- Judging by the color and density of foliage the trees were in fair-good health for the species and time of year. The trees also exhibited generally good structure having a dominant central leader with subordinate branching.
- There were several noticeable bumps and depressions on the northwest side of the artificial lawn bowling turf as well as repairs and holes from fungicide injections. These bumps ranged between about 35 and 60 feet from the subject trees. The red dotted section above indicates the area where most problems have been occurring.

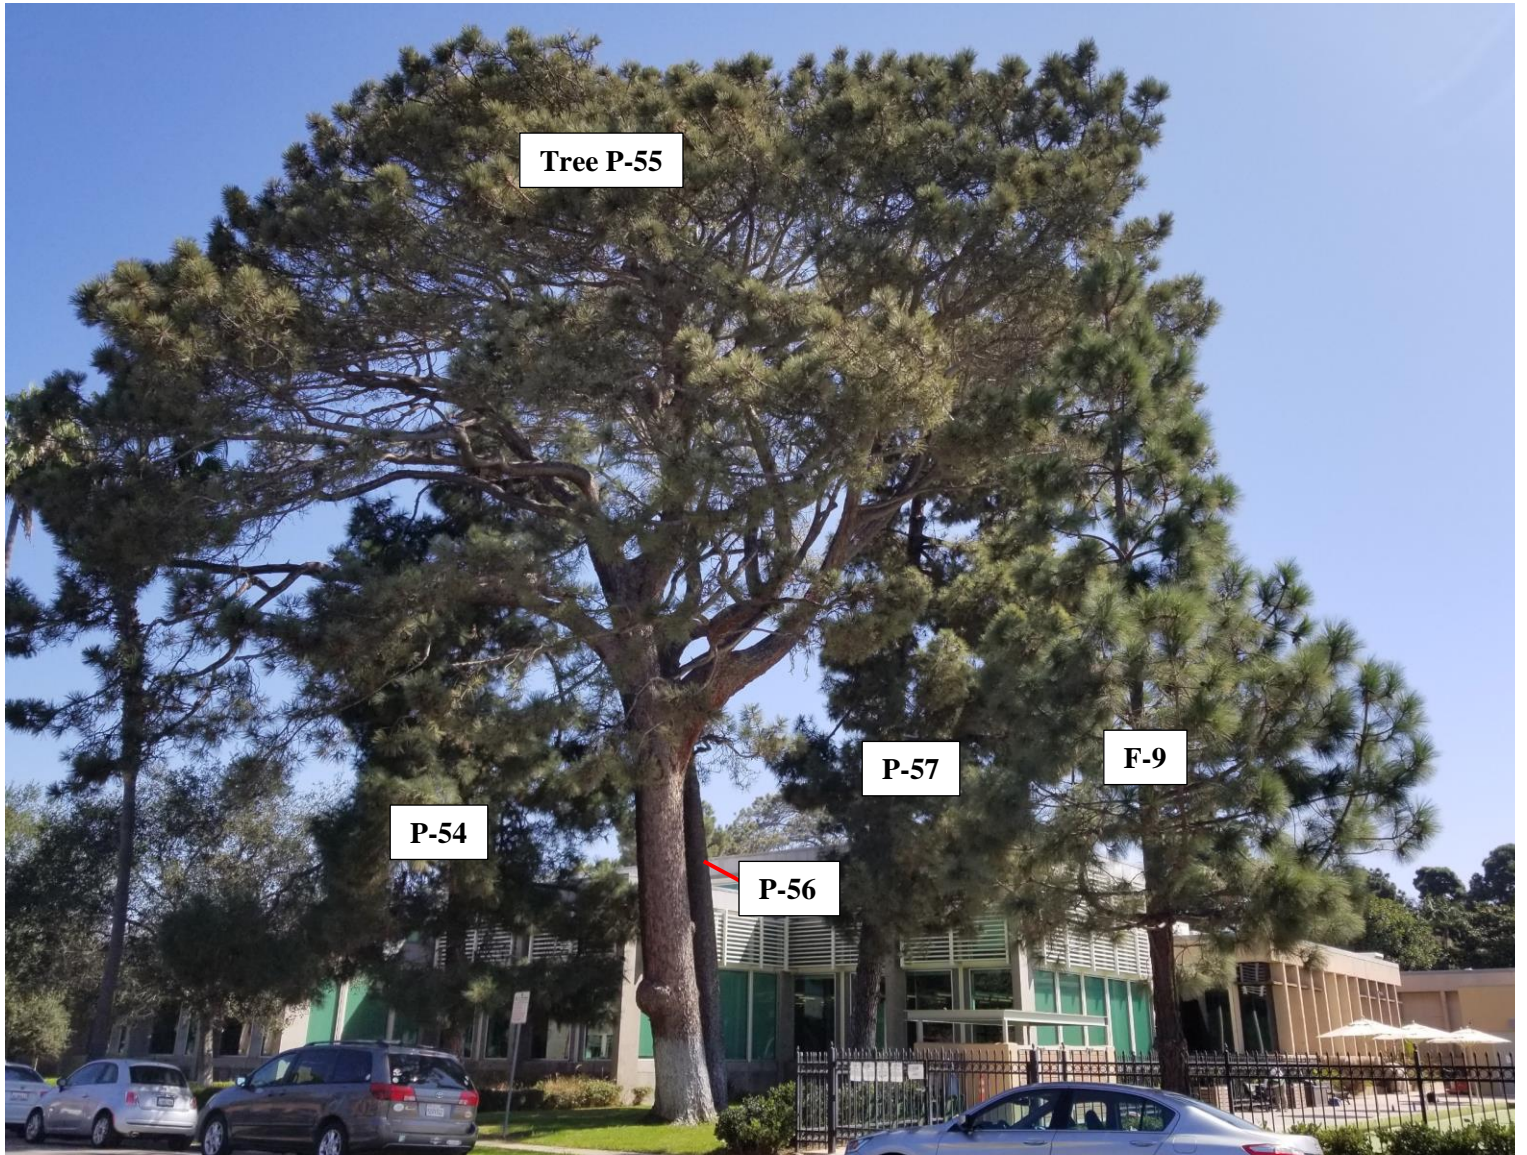
Photo #2

- **Tree P-55** had a height of about 90 feet and had a trunk diameter of 42 inches. The tree had a slight lean towards the northwest, likely in response to sunlight. The tree was quite mature and appeared to have multiple large bird nests in the upper canopy (likely egrets or herons). The tree's trunk was about 12 feet northeast of the bowling area's concrete footing, and about 60 feet from the nearest bump/ repair in the artificial turf.

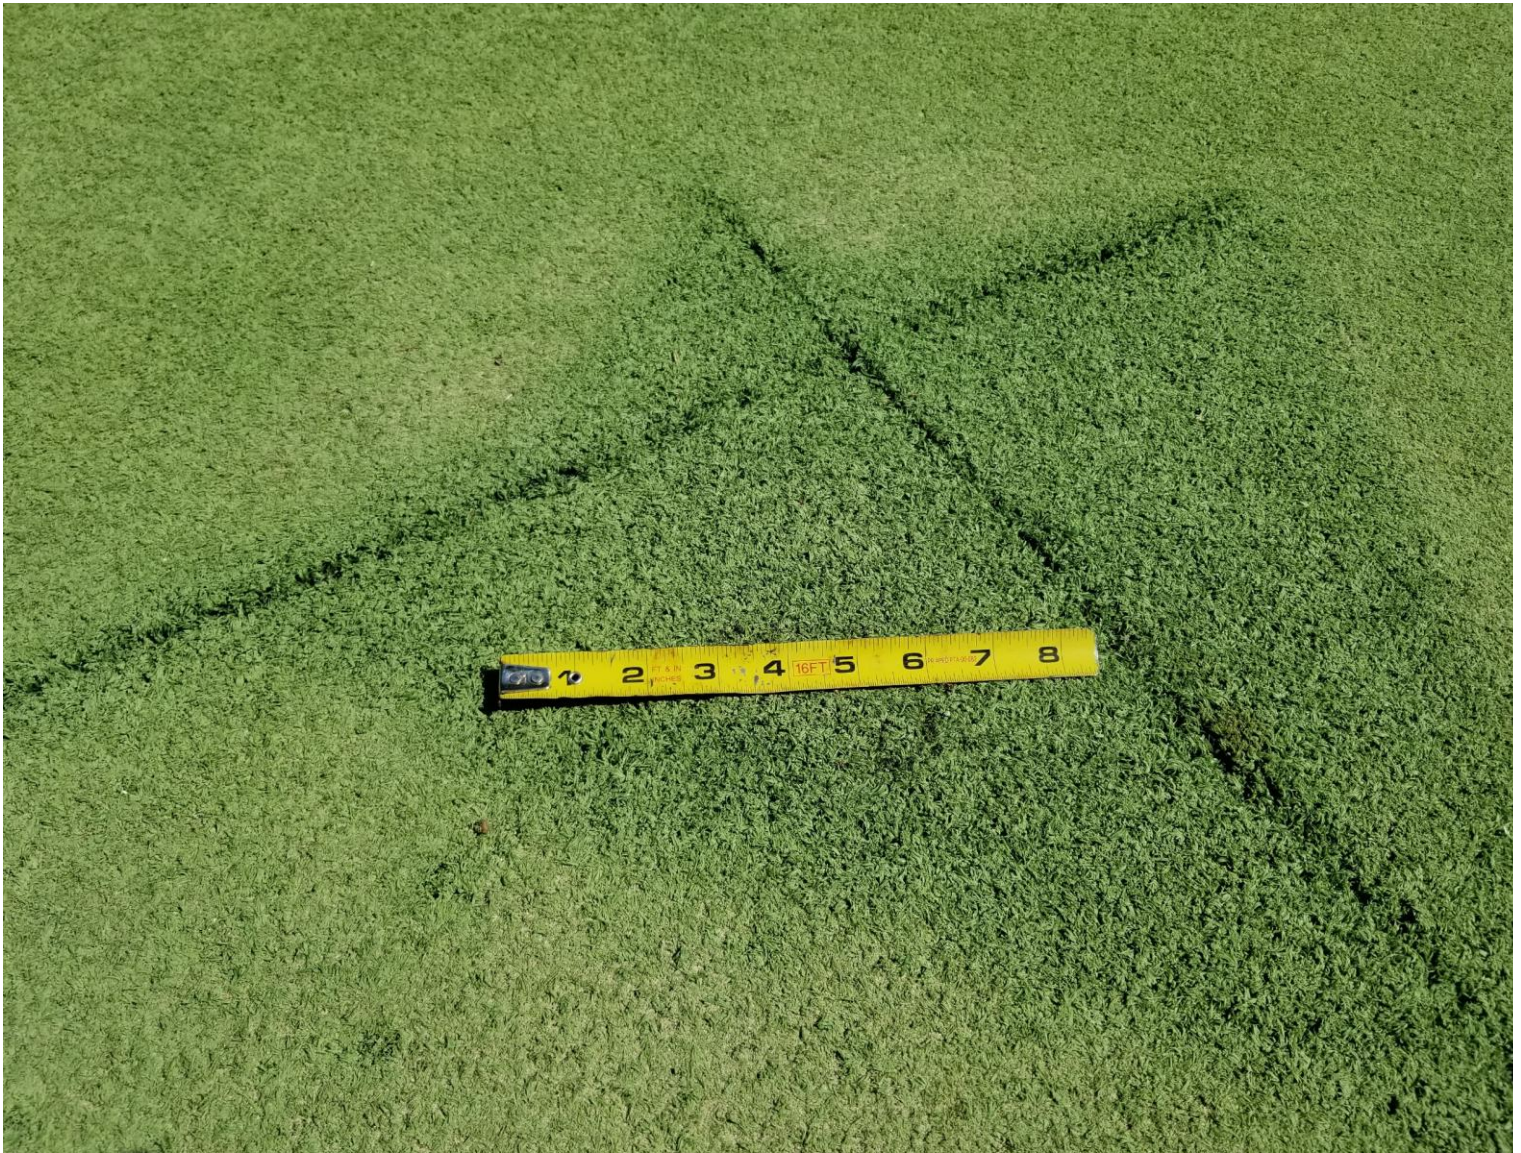
Photo #3

- Shown above in an image of an artificial turf repair.

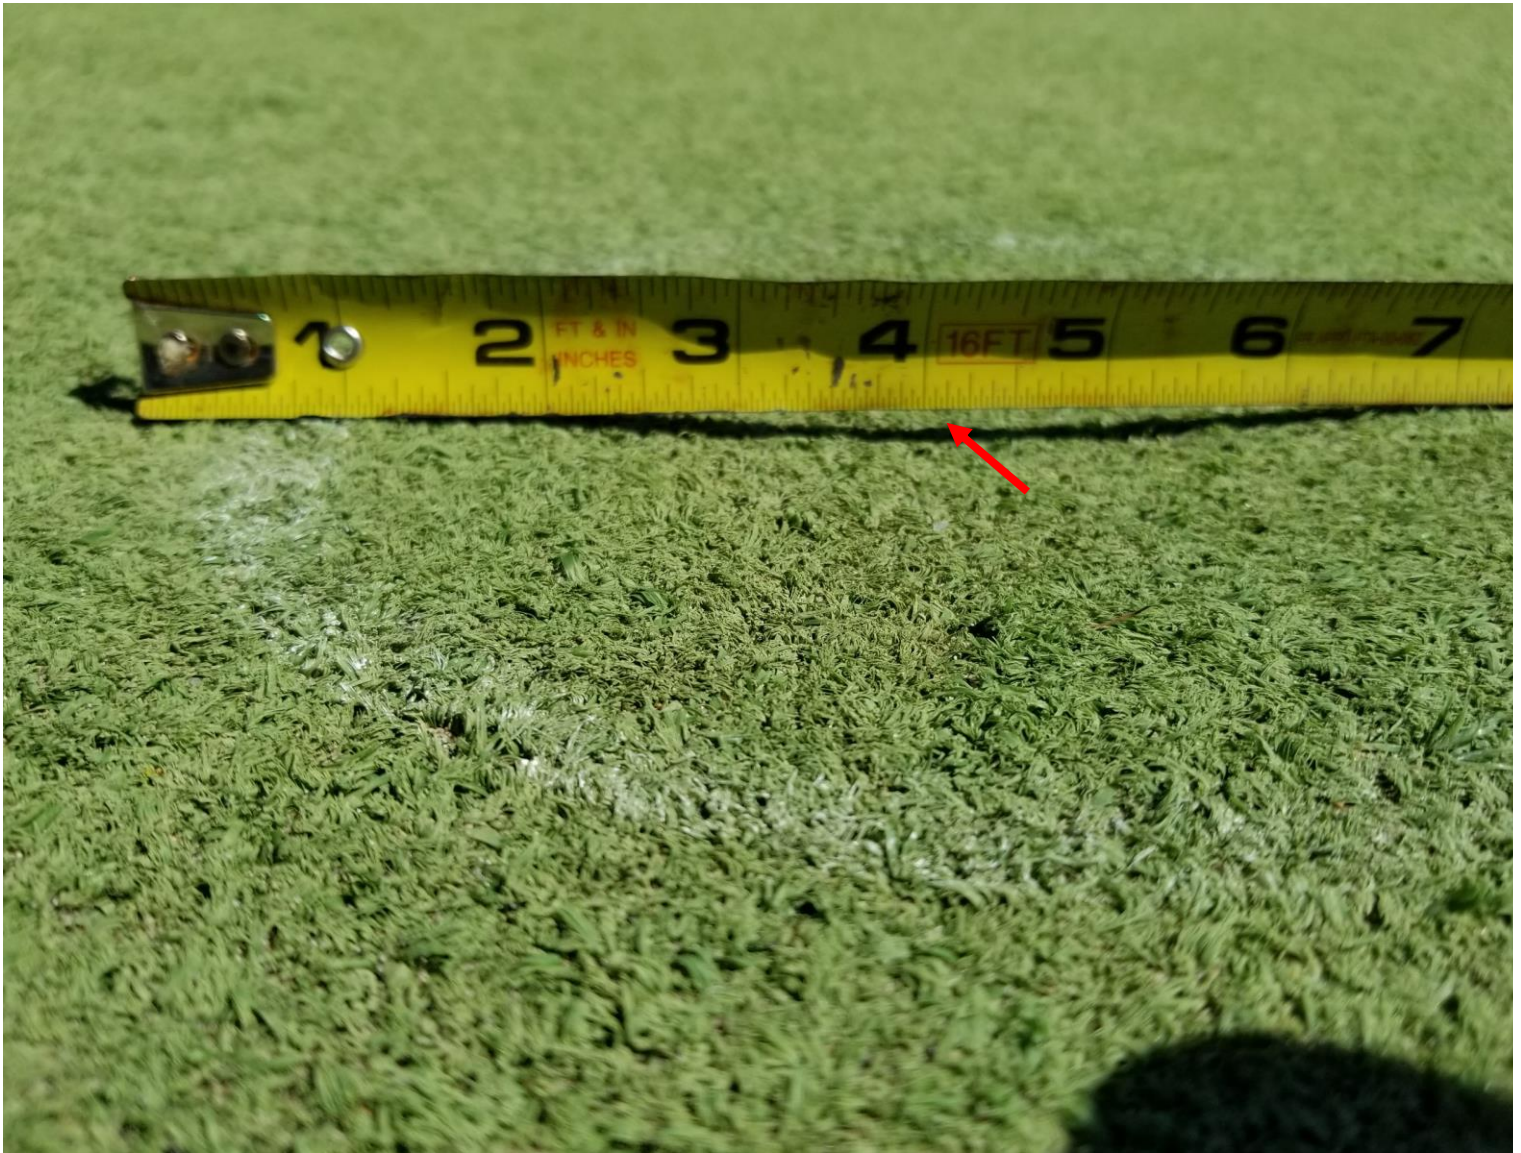
Photo #4

- Shown above in an image of a depression in the artificial turf (red arrow).

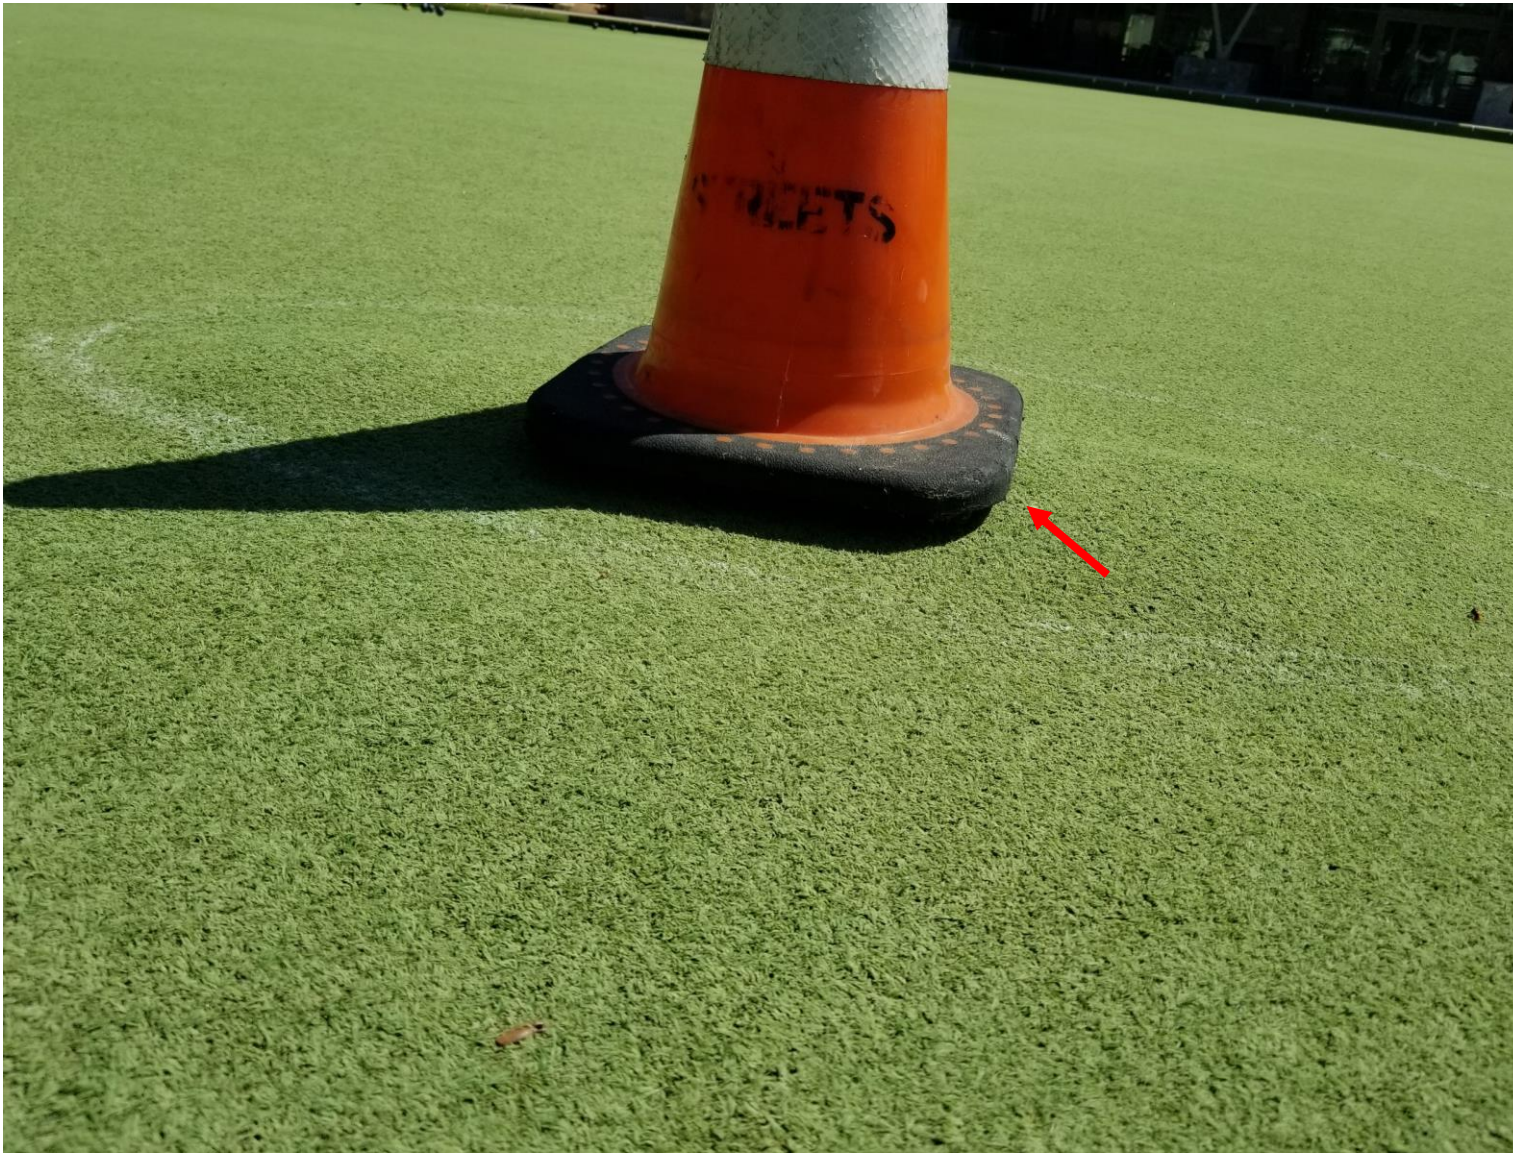
Photo #5

- Shown above is an image of a bump in the artificial turf (red arrow).

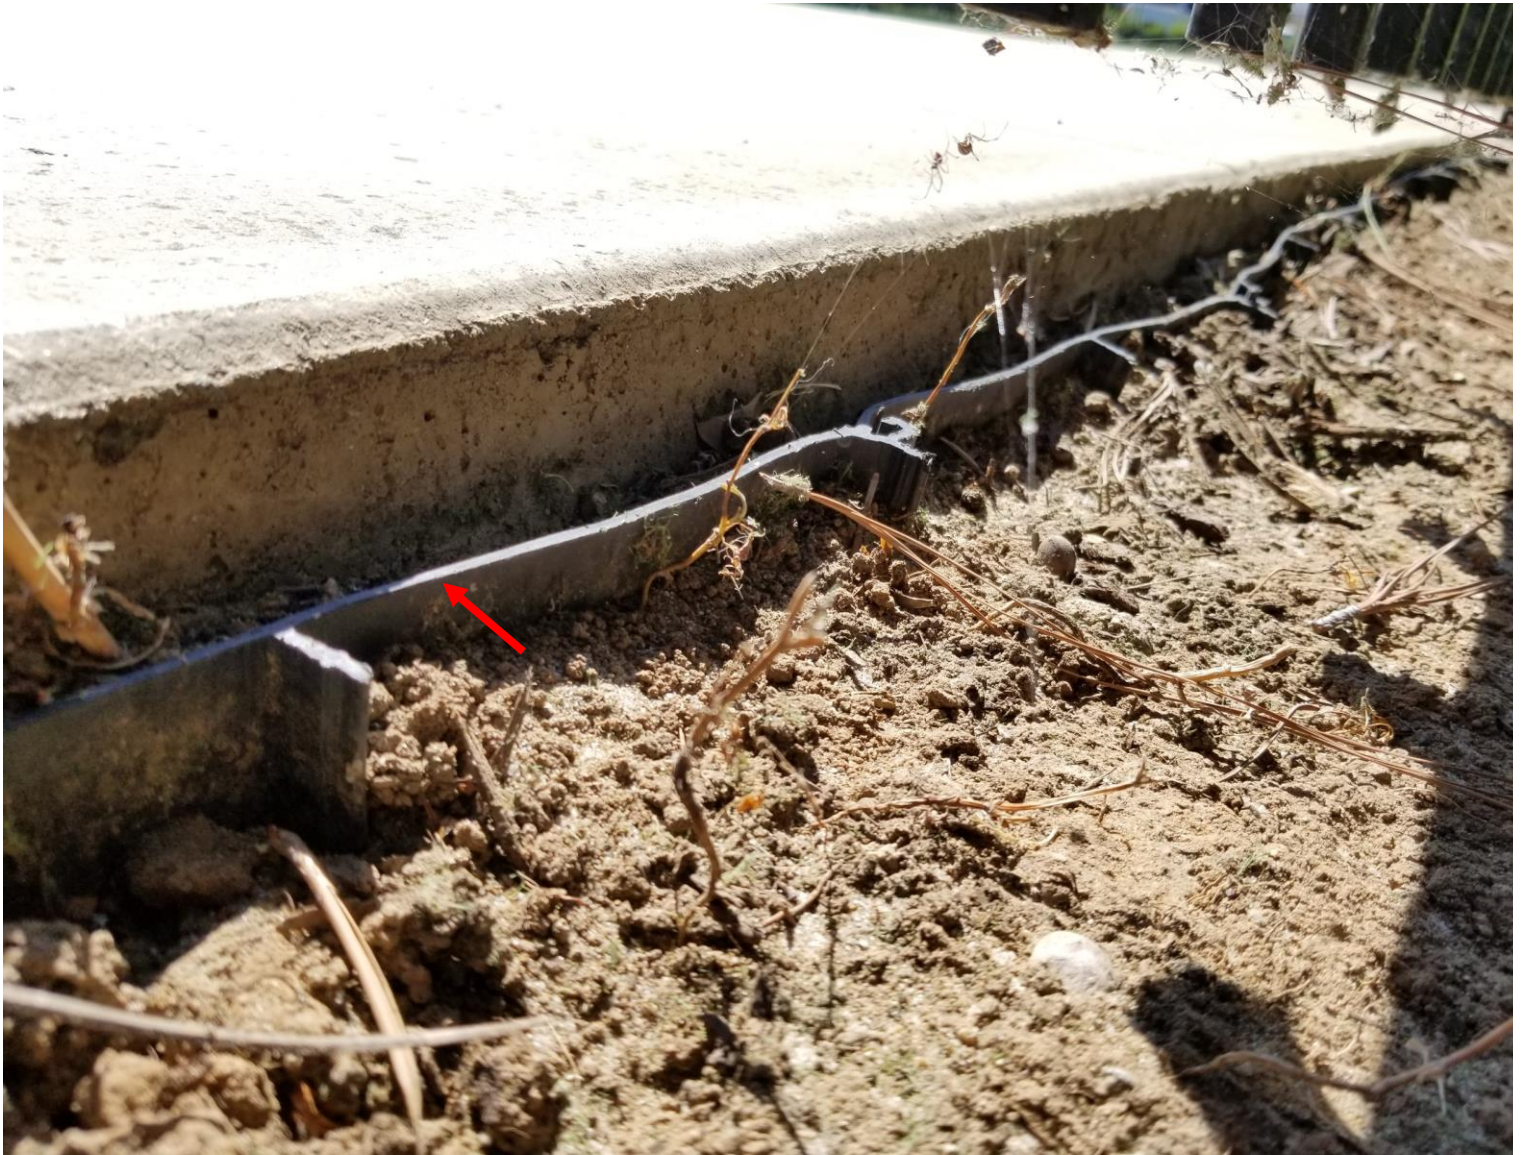
Photo #6

- There was a plastic root barrier (red arrow) between the privet hedge and the lawn bowling area.

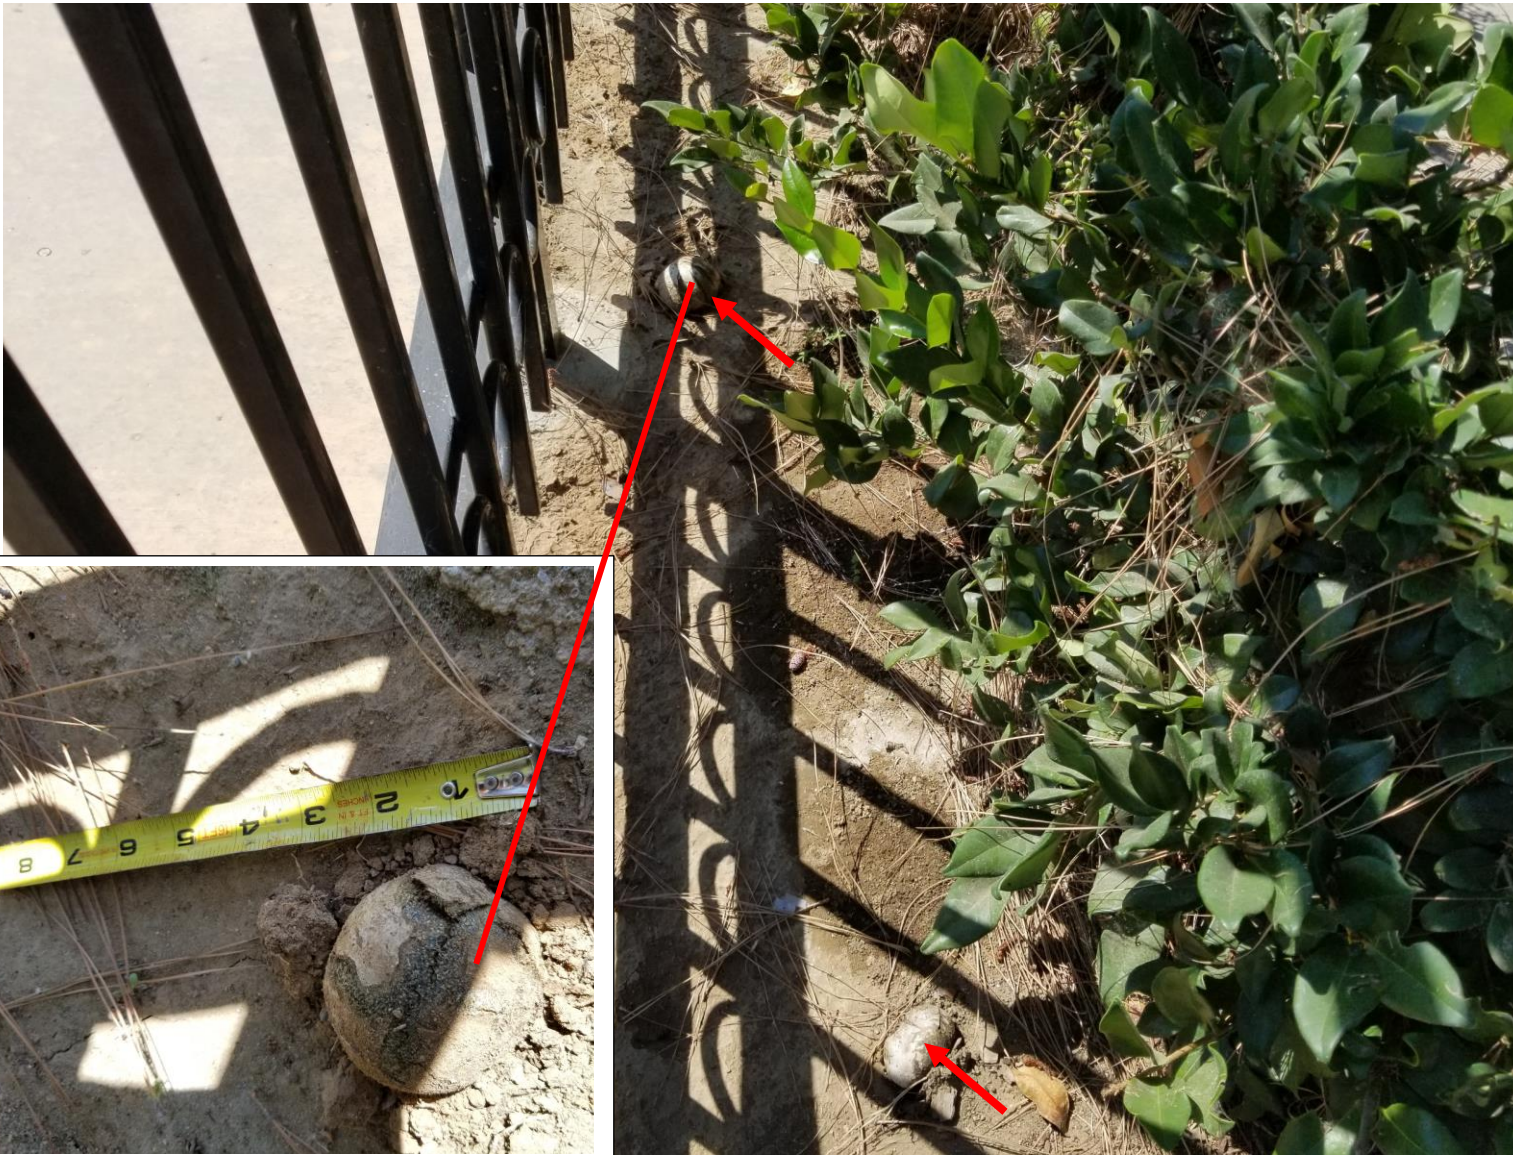
Photo #7

- There were numerous fungal fruiting bodies growing in the same planting area as the privet hedge (see **red arrows**). The mushroom species appeared to match the tentative identification of dyemaker's puffball (*Pisolithus tinctorius*) from the pathology report.

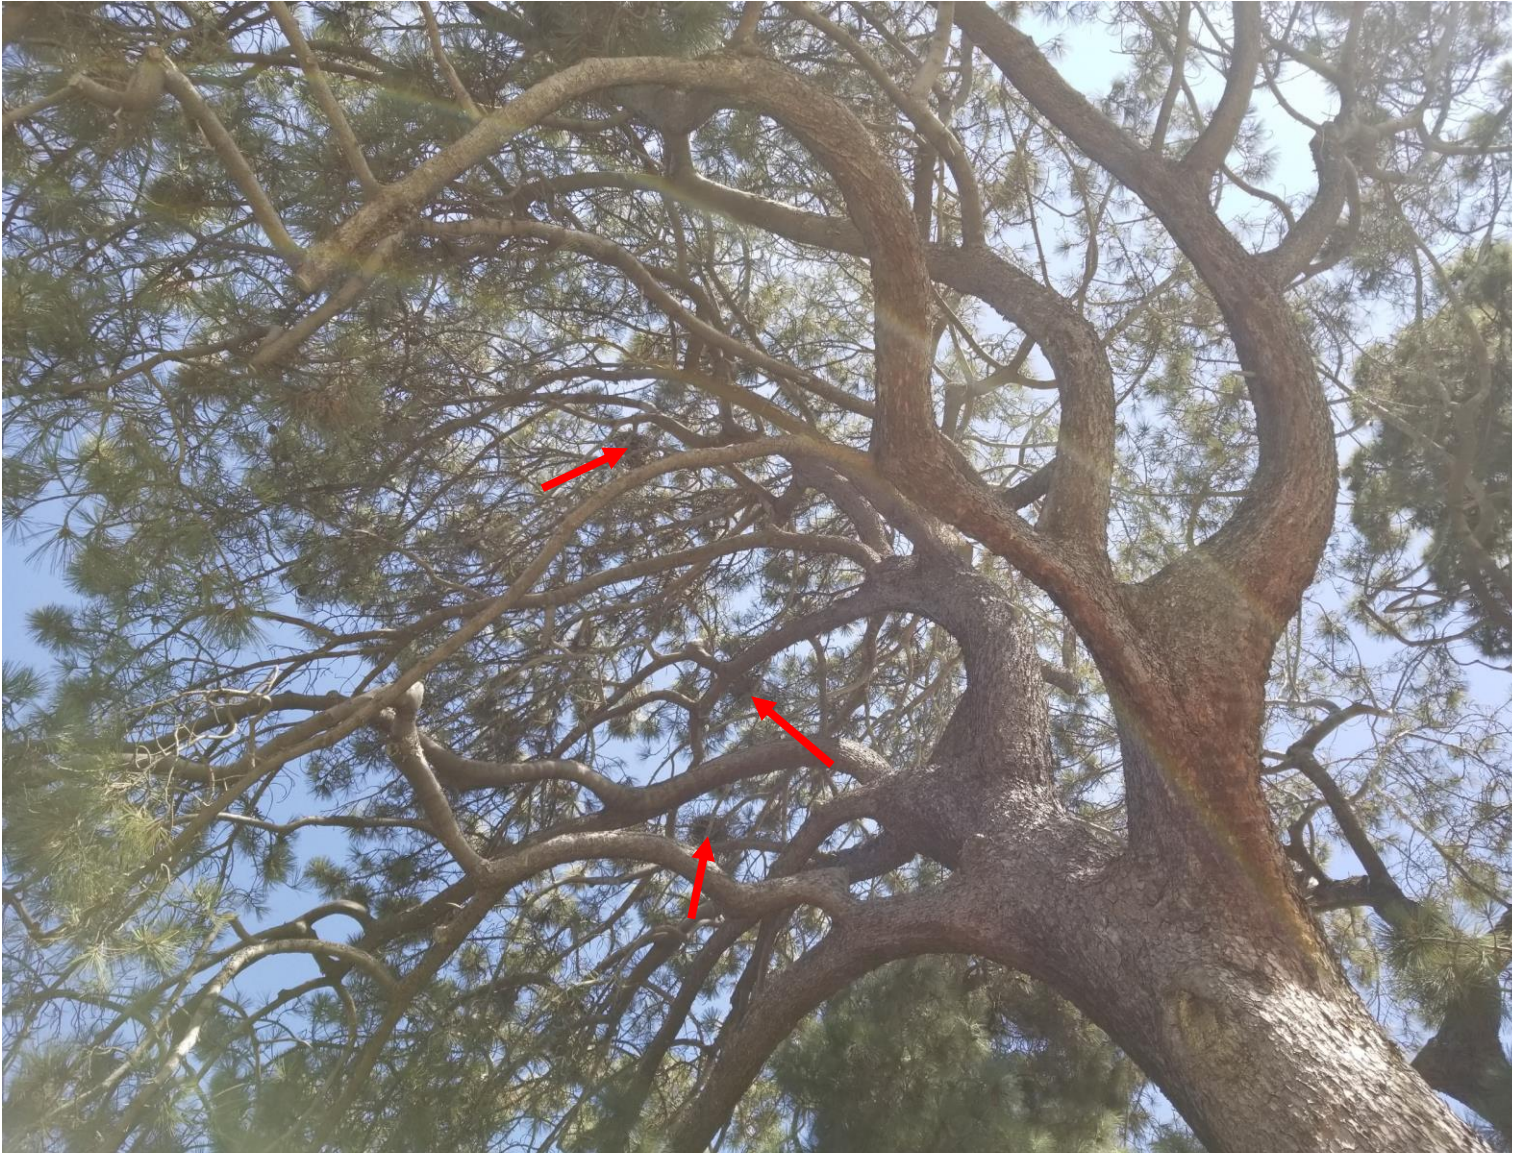
Photo #8

- Tree P-55 was quite mature and appeared to have multiple large bird nests (likely egrets or herons) in the upper canopy (see red arrows for some locations).

Bird Precautions – There were several large bird nests (likely egrets or herons) in the upper canopy of Tree P-55. There are numerous federal and state laws with serious consequences for protecting birds and their habitat. Collaborating with a wildlife biologist to identify the birds (if any) and review options before removing the tree or nests is recommended.

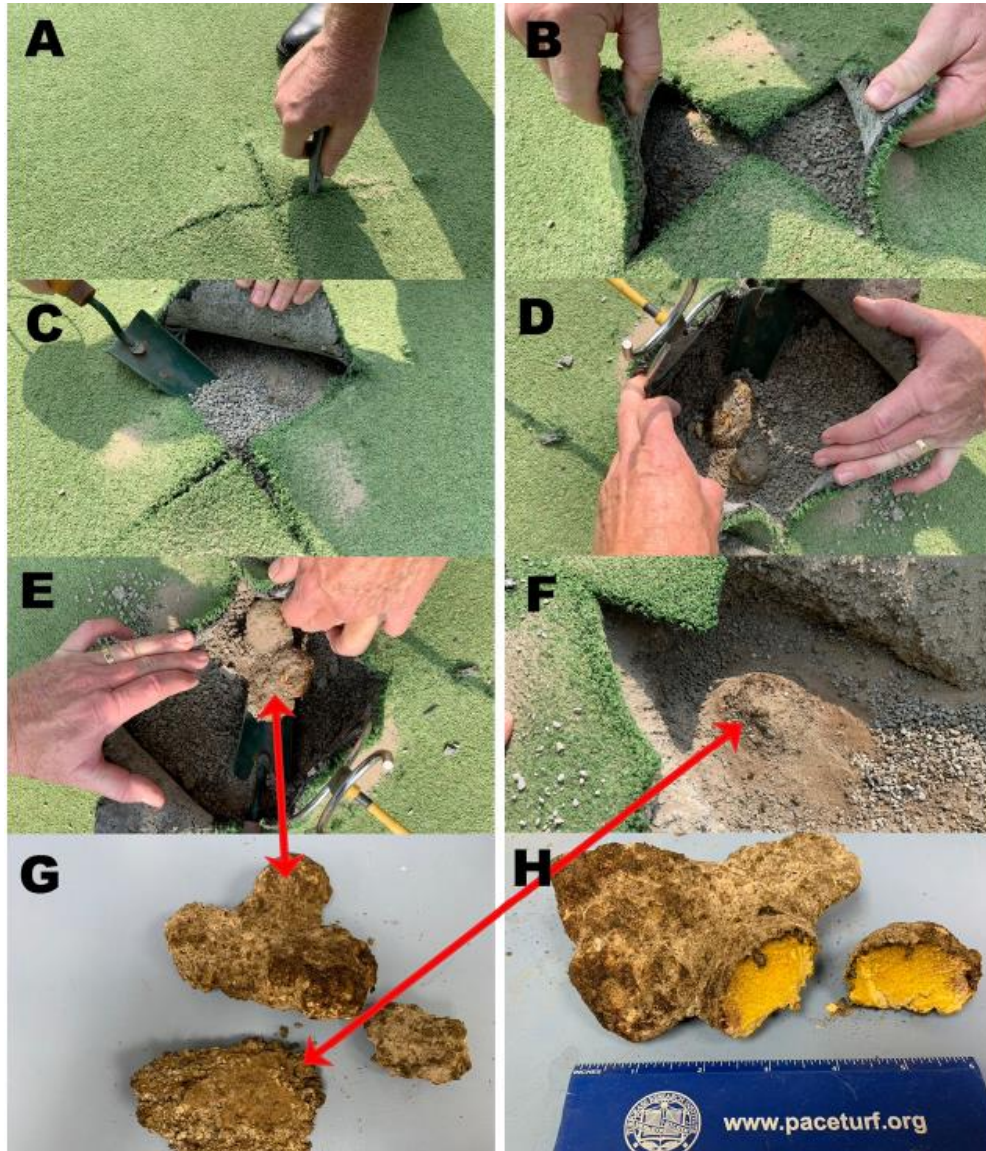
Photo #9

- Shown above is are images from PACE Turf, LLC's report showing the mushroom getting extracted from beneath the artificial turf.

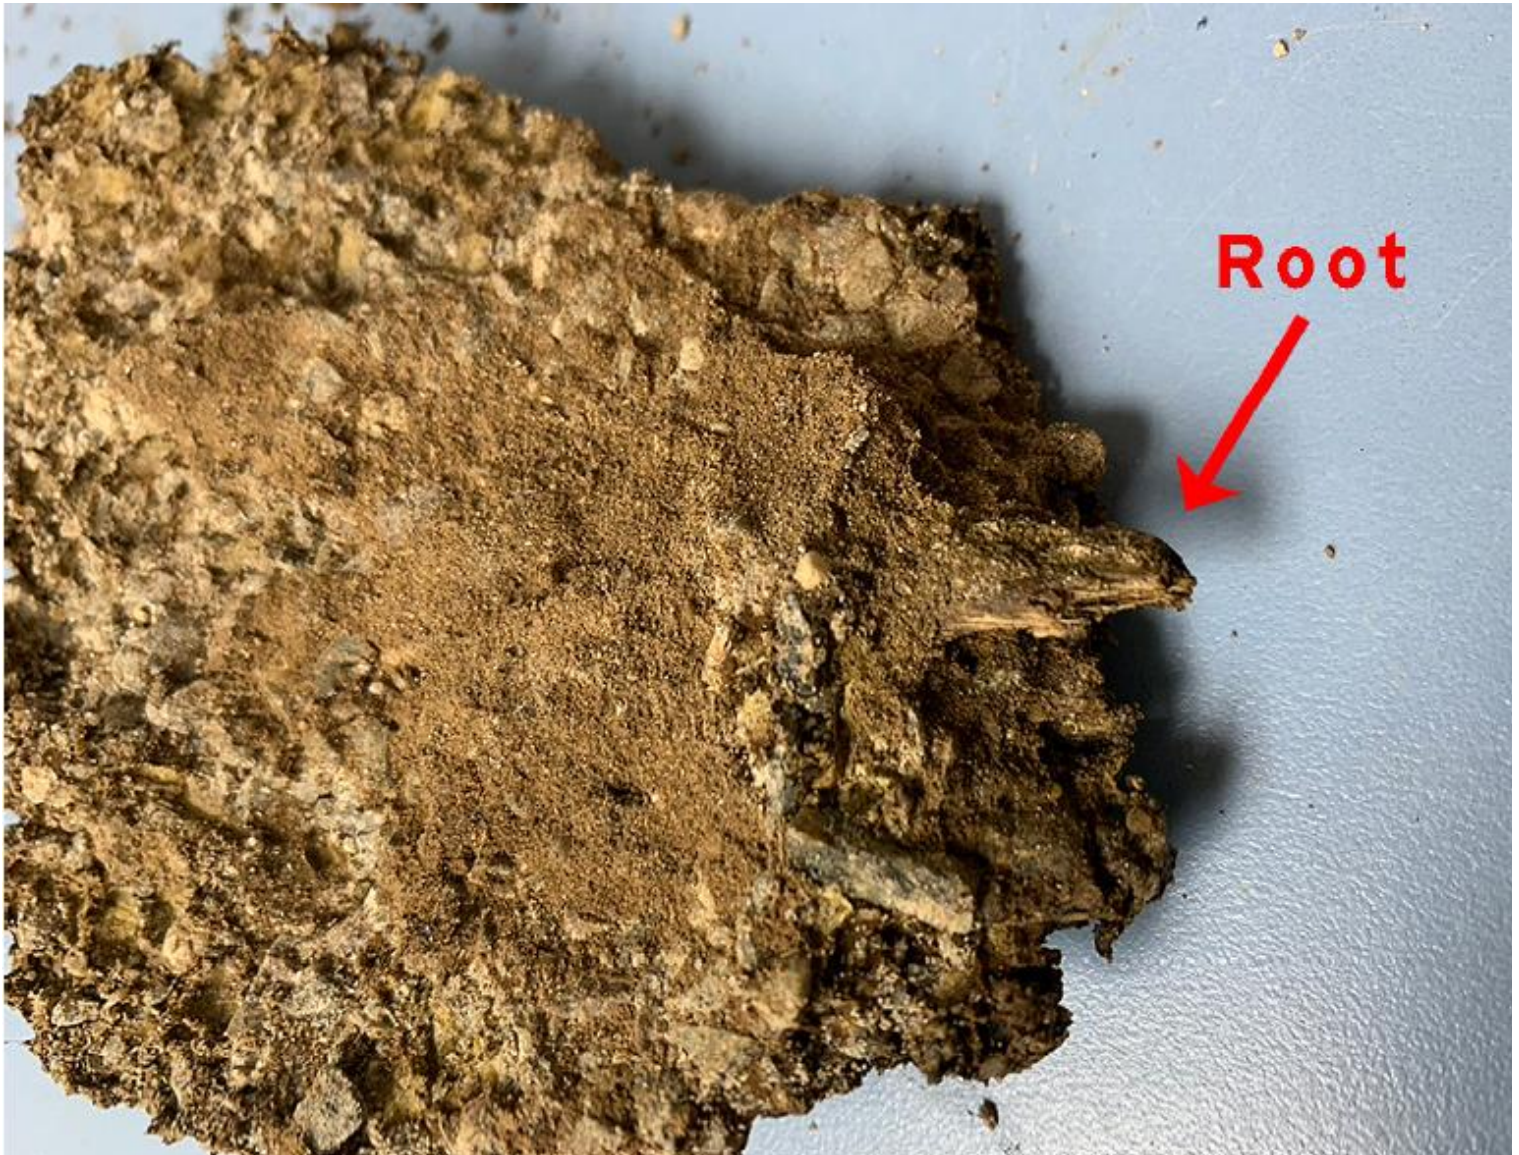
Photo #10

- Shown above is an image from PACE Turf, LLC's report showing a small root that was said to be a likely source of nutrition for the fungus. This root appeared to be dead, decaying, and was not identified to as being from a conifer.
