CITY OF CORONADO

CITY COUNCIL STAFF REPORT

REQUEST COUNCIL DIRECTION FOR FINAL DESIGN AND AUTHORIZE BID ADVERTISEMENT FOR THE LAWN BOWLING GREEN TURF REPLACEMENT PROJECT

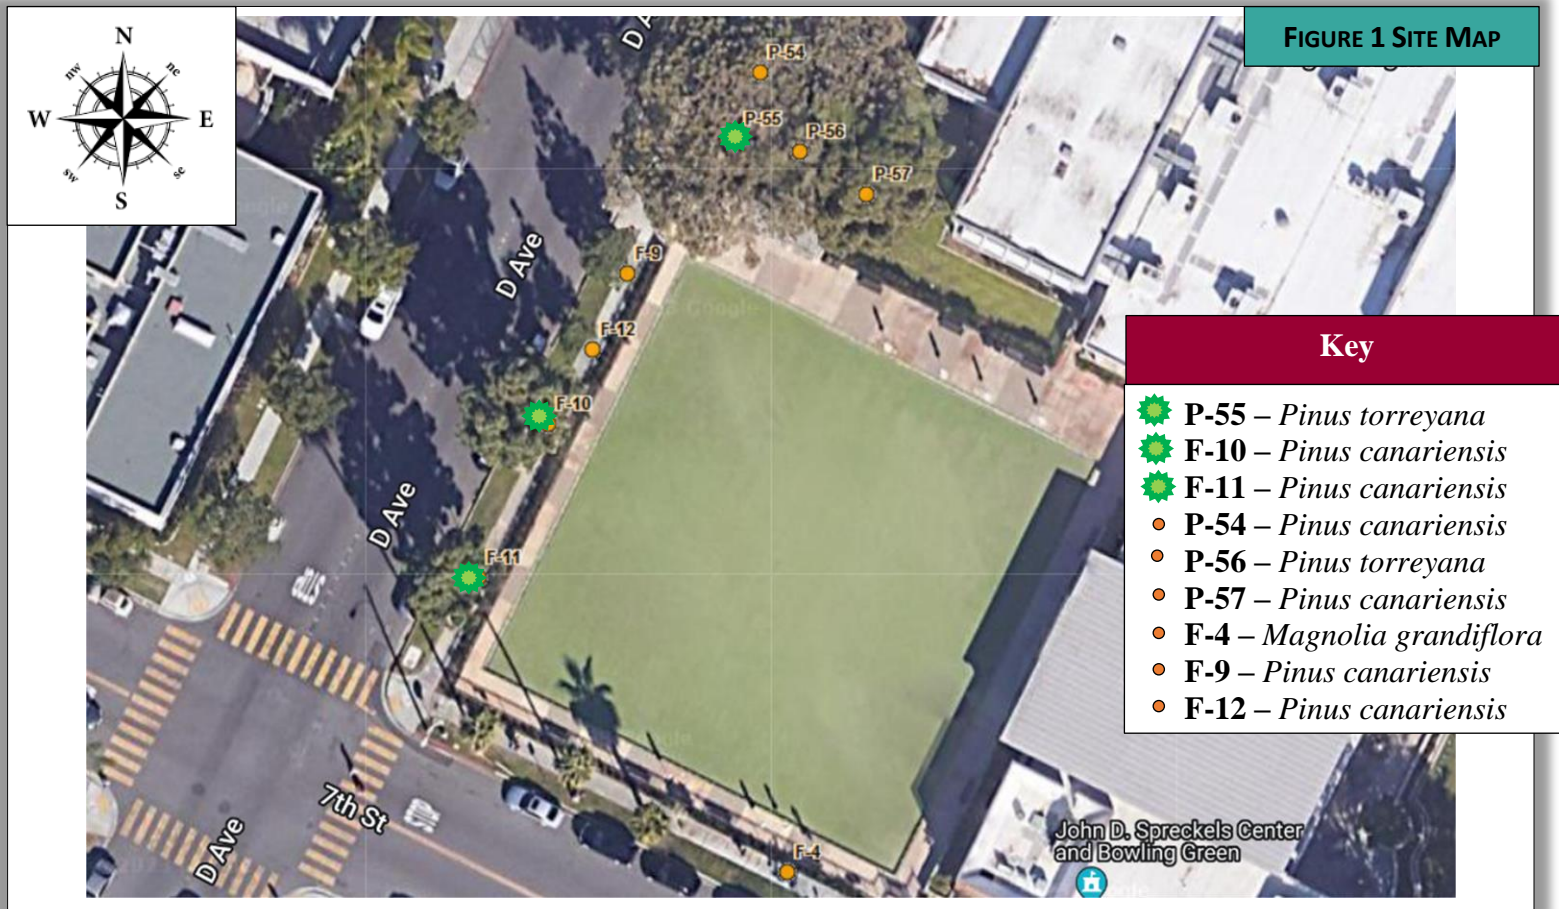
In September of 2020, West Coast Arborists, Inc. (WCA) was contacted by the City of Coronado regarding the assessment of one Torrey pine (*Pinus torreyana*) and two Canary Island pines (*Pinus canariensis*) trees located on the northwest side of the Coronado lawn bowling club. In Arbor Access (WCA's tree inventory database), the trees are inventoried as 2 X SPRECKELS PARK WEST PLAZA P-55, 601 D AV F-10, and 601 D AV F-11. For this report, the trees will be referred to as Tree P-55, Tree F-10, and Tree F-11. The site map below identifies the location of these three subject trees with this icon "🌲" and six other surrounding trees with this icon "🌳".

The City had concerns regarding fungal fruiting bodies that were creating lumps within the artificial lawn bowling turf. The City requested that WCA assess the situation and provide management recommendations from an arboricultural perspective¹, specifically regarding the three subject pine trees (P-55, F-10, & F-11) being considered for removal to mitigate these turf problems.
